SEALING SENSE

How to troubleshoot expansion joint failures

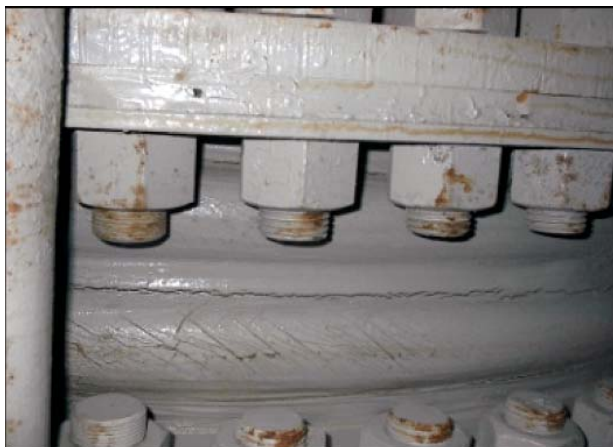
Exterior surface cracking is most commonly the result of aging and/or elevated temperature. As rubber ages, it becomes hard and brittle and loses inherent flexibility and resilience. Cracking or crazing may not be serious if only the outer cover is involved and the fabric is not exposed. If necessary, repair onsite with rubber cement where cracks are minor. Carefully inspect cracks to determine if underlying fabric reinforcing plies are compromised.

Figure 1. Typical Expansion Joint Surface Cracking

Cracking where the fabric is exposed and torn, indicates the expansion joint should be replaced. Such cracking is usually the result of excess extension, angular or lateral movements. Such cracking is identified by (1) a flattening of the arch, (2) cracks at the base of the arch and/or (3) cracks at the base of the flange. Cracking at the base of the flange/arch is more associated with movement and misalignment.

Note: As a corrective action, measure the face-to-face and lateral alignment prior to ordering a replacement and install control units to maintain acceptable movement limits of the expansion joint during operation.

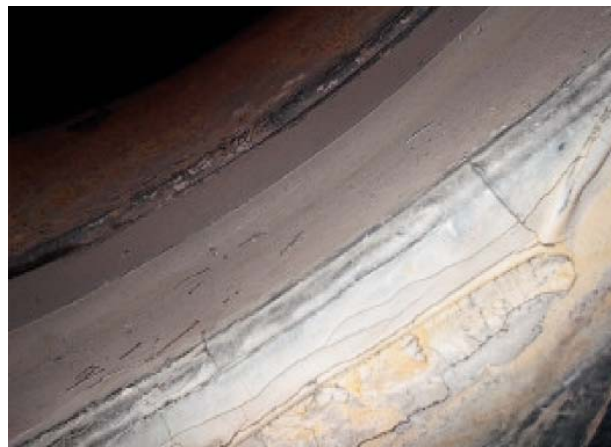
Some blisters or deformations—when on the external portions of an expansion joint—may not adversely affect the performance of the expansion joint. These blisters or deformations are cosmetic in nature and do not require repair.

If major blisters, deformations and/or ply separations or delamination exist in the tube, the expansion joint should be replaced as soon as possible. The root cause of delamination is either over-torqued bolts, chemical attack by the media, aged rubber or some other form of break in the inner tube layer. Corrective actions include replacing the aged product and ensuring the correct material selection for the application.

Figure 2. Expansion Joint Surface Delamination

Ply separation at the flange outer diameter (O.D.) can sometimes be observed and is not a cause for replacement of the expansion joint.

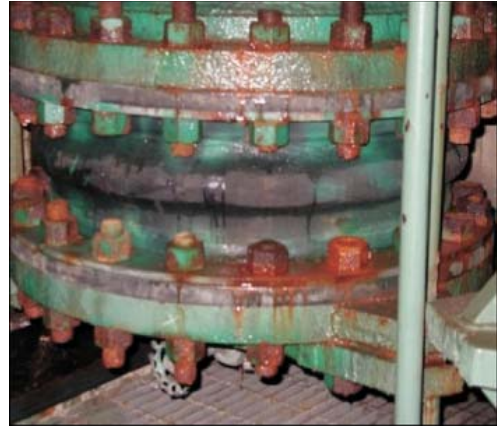
It is most important to determine where the leak originated prior to implementing any corrective action. If leakage or weeping is occurring from any surface of the expansion joint, except where flanges meet, replace the joint immediately. If leakage occurs between the mating flange and expansion joint flange,

Figure 3.
Leaking
Expansion
Joint

tighten all bolts. (Make sure that a gasket has NOT been installed between the joint's flange face and the mating flange.)

If this is not successful, turn off the system pressure, loosen all flange bolts and then retighten bolts in stages by alternating around the flange. Make sure there are washers under the bolt heads, particularly at the split in the retaining rings. There should be no gap at the retaining ring split. Remove the expansion joint and inspect both rubber flanges and pipe mating flange faces for damage and surface condition. Repair or replace as required. Also, make sure the expansion joint is not over-elongated as this can tend to pull the joint flange away from the

Root Causes Include: Under-torqued bolts; irregular sealing surface (optimal mating surface is full face flat flanges); over-extension; and chemical attack by the media.

Corrective Action: Tighten the bolts to the manufacturer's torque recommendations. Change to proper design and chemically compatible material. Measure the face-to-face dimension prior to replacement.
